# Manhole Inspection Summary

Manhole # S23I\_\_011MH

Insp Date: 11/21/08 12:59 PM

**Location** Address: **Lemmon St.**

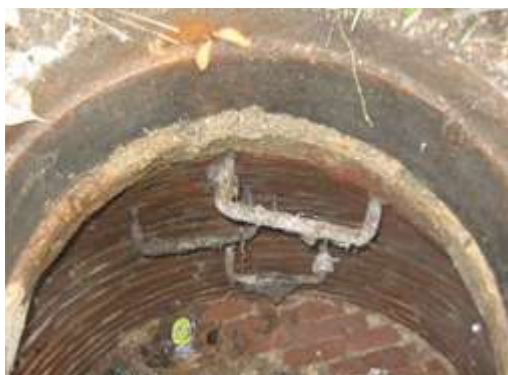
Defect 4

Infiltration: ☐ None ☐ Joint ☐ Cracks ☐ Mortar ☐ Roots ☒ **Wall**

**Steps** Count: **3** Missing: **0** ☒ **Corroded**

chimney infiltration and corroded steps

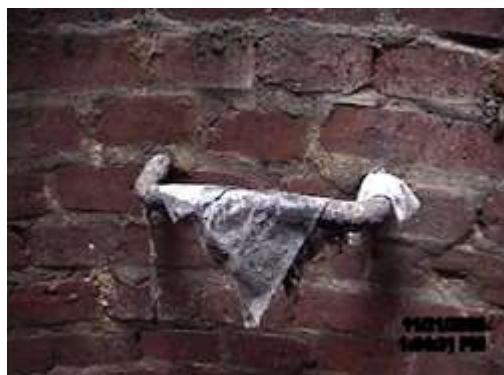
Defect 1

**Surcharge** ☒ **Evidence Of Surcharge** Depth: **1** (ft.) ☐ Active Surcharge Present

surcharge on step

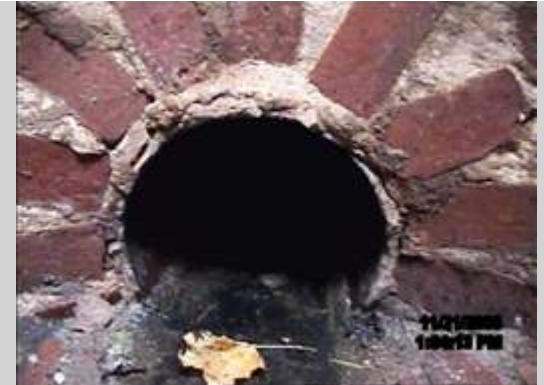
12 O'Clock Outflow

8 in. Circular Gravity Sewer  
Pipe Out @ 12 O'Clock

Infiltration: **None** Pipe Seal Cond: **Sound**
